Docket No. 217 - Development and Management Plan Inspection

Northeast Utilities Service Company Certificate of Environmental Compatibility and Public Need for the construction of a 345-kV electric transmission line and reconstruction of an existing 115-kV electric transmission line between Connecticut Light and Power Company's Plumtree Substation in Bethel, through the towns of Redding, Weston, and Wilton, and to the Norwalk Substation in Norwalk, Connecticut.

Date: November 10, 2005

Location: Overhead Line (Composite 345kV and 115kV Gallows Hill to Archers Lane)

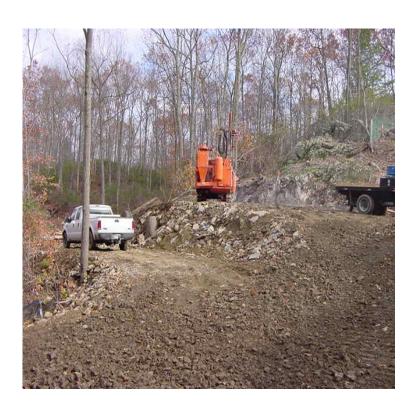
Overhead ROW: The photo on the left shows drilling activities for the structure that will be placed at the edge of the Archers Lane station. The photo on the right is a view of the ROW from the Archers Lane access. 11/10/05

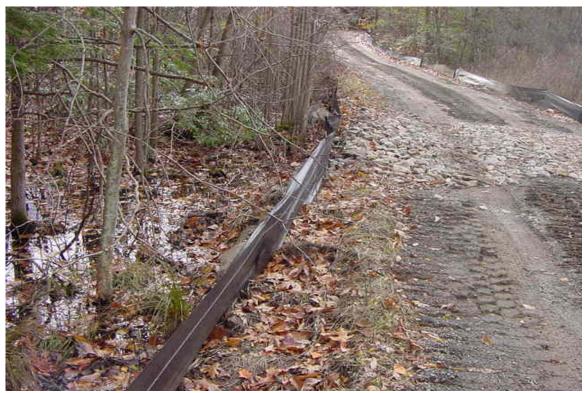
- The spot near Archers Lane is working well and clear standing water was noted in the adjacent wetlands. 11/10/05	- None at this time. 11/10/05
	- Further sedimentation was not noted in the wetland near Gallows Hill and haybales were still in place. 11/2- 11/10/05	-Continue to monitor this area but none at this time. 11/2-11/10/05

View of the low spot/wetland crossing on the access road in from Archers Lane. Standing water in the adjacent wetlands was clear and erosion controls are in good shape. 11/10/05

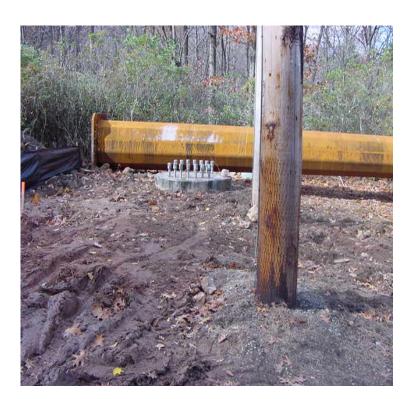
Photo on the left shows a foundation with a pole structure placed for future installation. Photo on the right shows the view back towards Archers Lane and the clearing performed here to access the ROW. 11/10/05

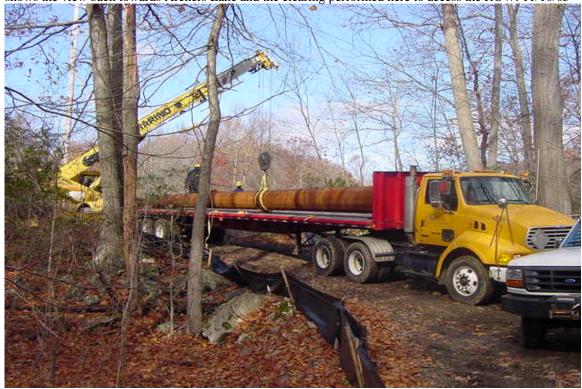
View of a pole being off-loaded to the ROW. 11/10/05

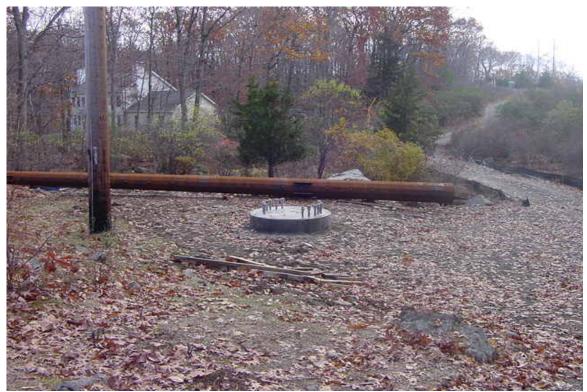
View of the second structure in from Gallows Hill Rd. with the foundation in place and the pole ready for future installation. 11/10/05

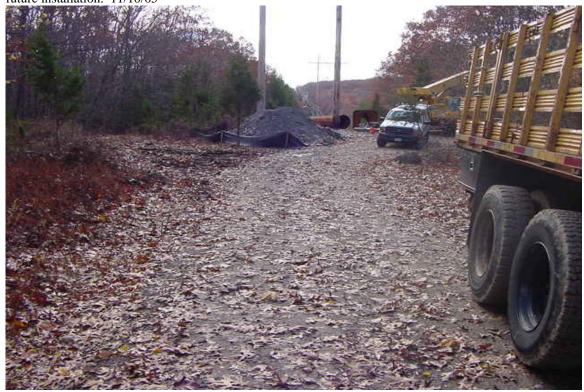
- Silt fence was in place around several stockpiles on the ROW. Almost all are in upland locations. 11/10/05	- Silt fence could be extended along at one of the upland piles if sedimentation issues are noted. 11/10/05

View of a stockpile noted at a structure. Silt fence could be extended here if any sedimentation issues are noted but the work area is in uplands. 11/10/05
